## 2012 NYCT Steinway Tube – Duct Bench Rehabilitation

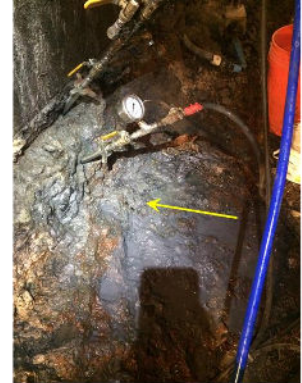
Leak Area

Drilled Hole with Packer

Dyed Inhibitor  
Confirming Connection

NOH2O Sealing the Leak
